What We Know About the Riparian Health of Wabamun Lake

By Michelle A. Gordy, Ph.D.,

Watershed Planning Coordinator, North Saskatchewan Watershed Alliance

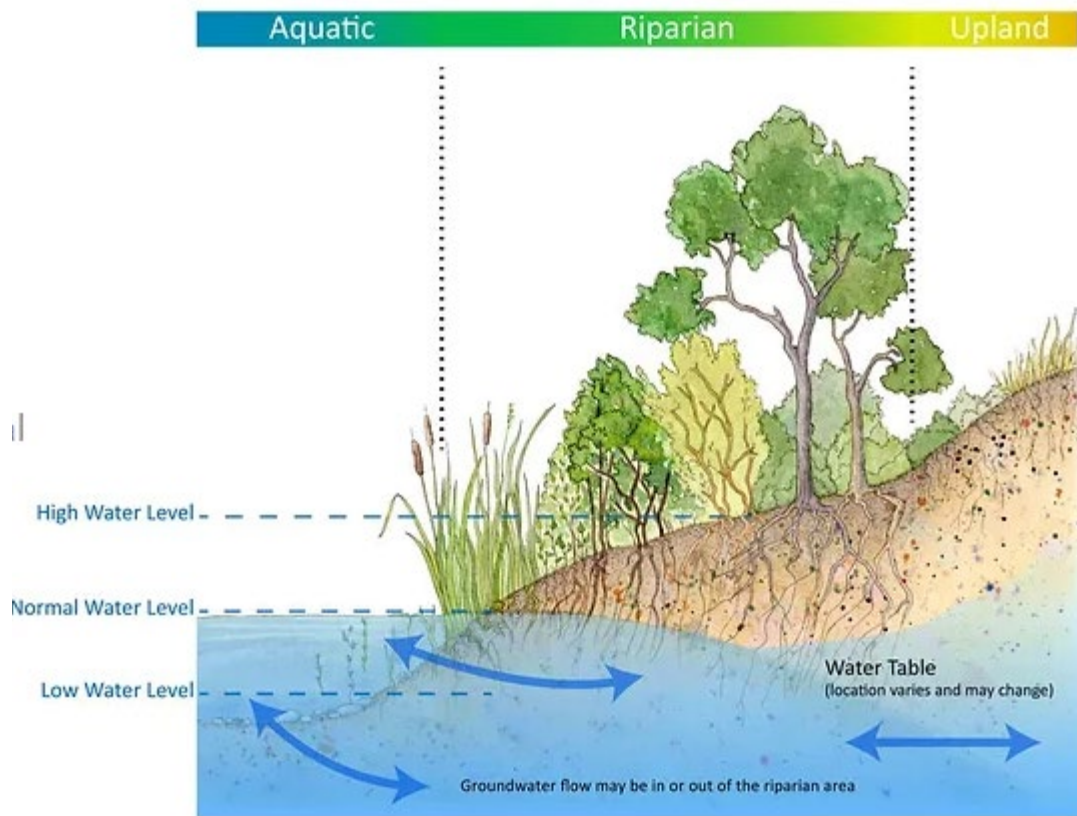
Figure 2. Illustration of a riparian area. The illustration shows the transition from upland to riparian to aquatic zones. Image: Cows and Fish

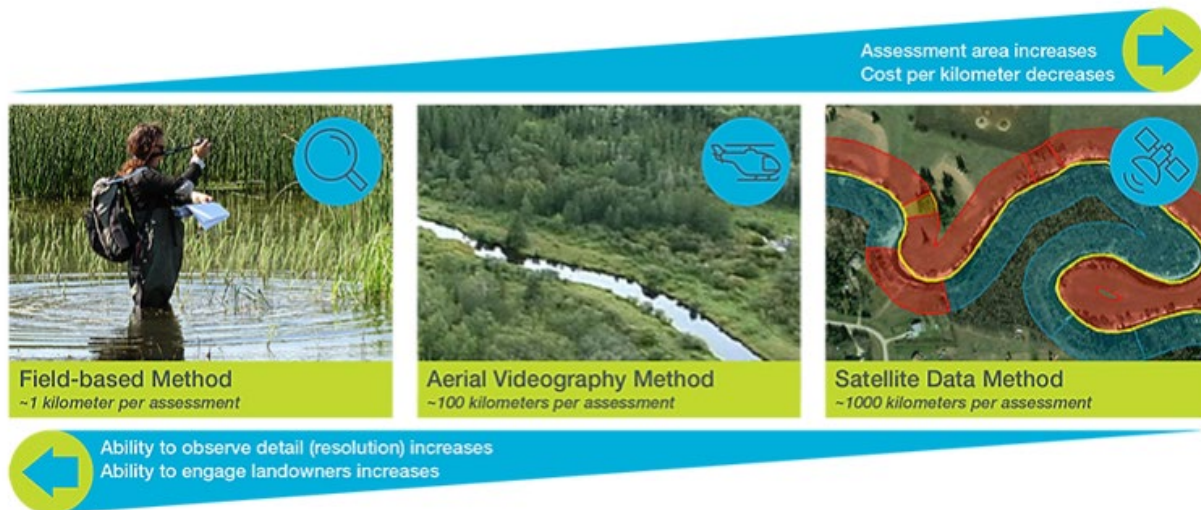
Figure 4 Comparison of three different methods for assessing riparian condition.

The field-based method is the gold standard because a great amount of detail can be gathered on riparian function. Here, someone physically visits the location and identifies specialized plants and characterizes soil health. Given that there are an estimated 1.3 million kilometres of riparian area in Alberta, this method can be limited by cost, available experts, and restrictions related to gaining permission from landowners to access riparian lands. Typically, one assessment covers one landowner’s property and offers excellent insights before and after restoration projects.

Aerial videography assessment methods offer an excellent complement to the field-based technique. These methods involve using imagery to assess an entire waterbody from a remote location. For the past two decades, aerial assessments have involved a desktop assessment using videography captured via helicopter or UAV (a.k.a drone). Some details, such as soil samples, are excluded from this assessment at the trade-off of gaining a wider assessed area. Wabamun Lake was assessed using this method in 2014 (NSWA, 2015).

The modernization of the aerial assessment method came a few years later. The availability of high-resolution satellite imagery allowed the assessments to include an even wider area. Furthermore, satellite imagery provided the capacity to assess upland areas that put pressure on riparian areas. These two datasets combine to indicate where more significant conservation and restoration efforts are needed on the landscape. Wabamun Lake was included, along with another 22 lakes and 28 creeks, in an innovative pilot project published in 2018 (Fiera, 2018). Excitingly, since that pilot project was completed, over 49,000 km of shoreline have been assessed using this new technique, filling a wide data gap about the condition of riparian areas in our watershed.

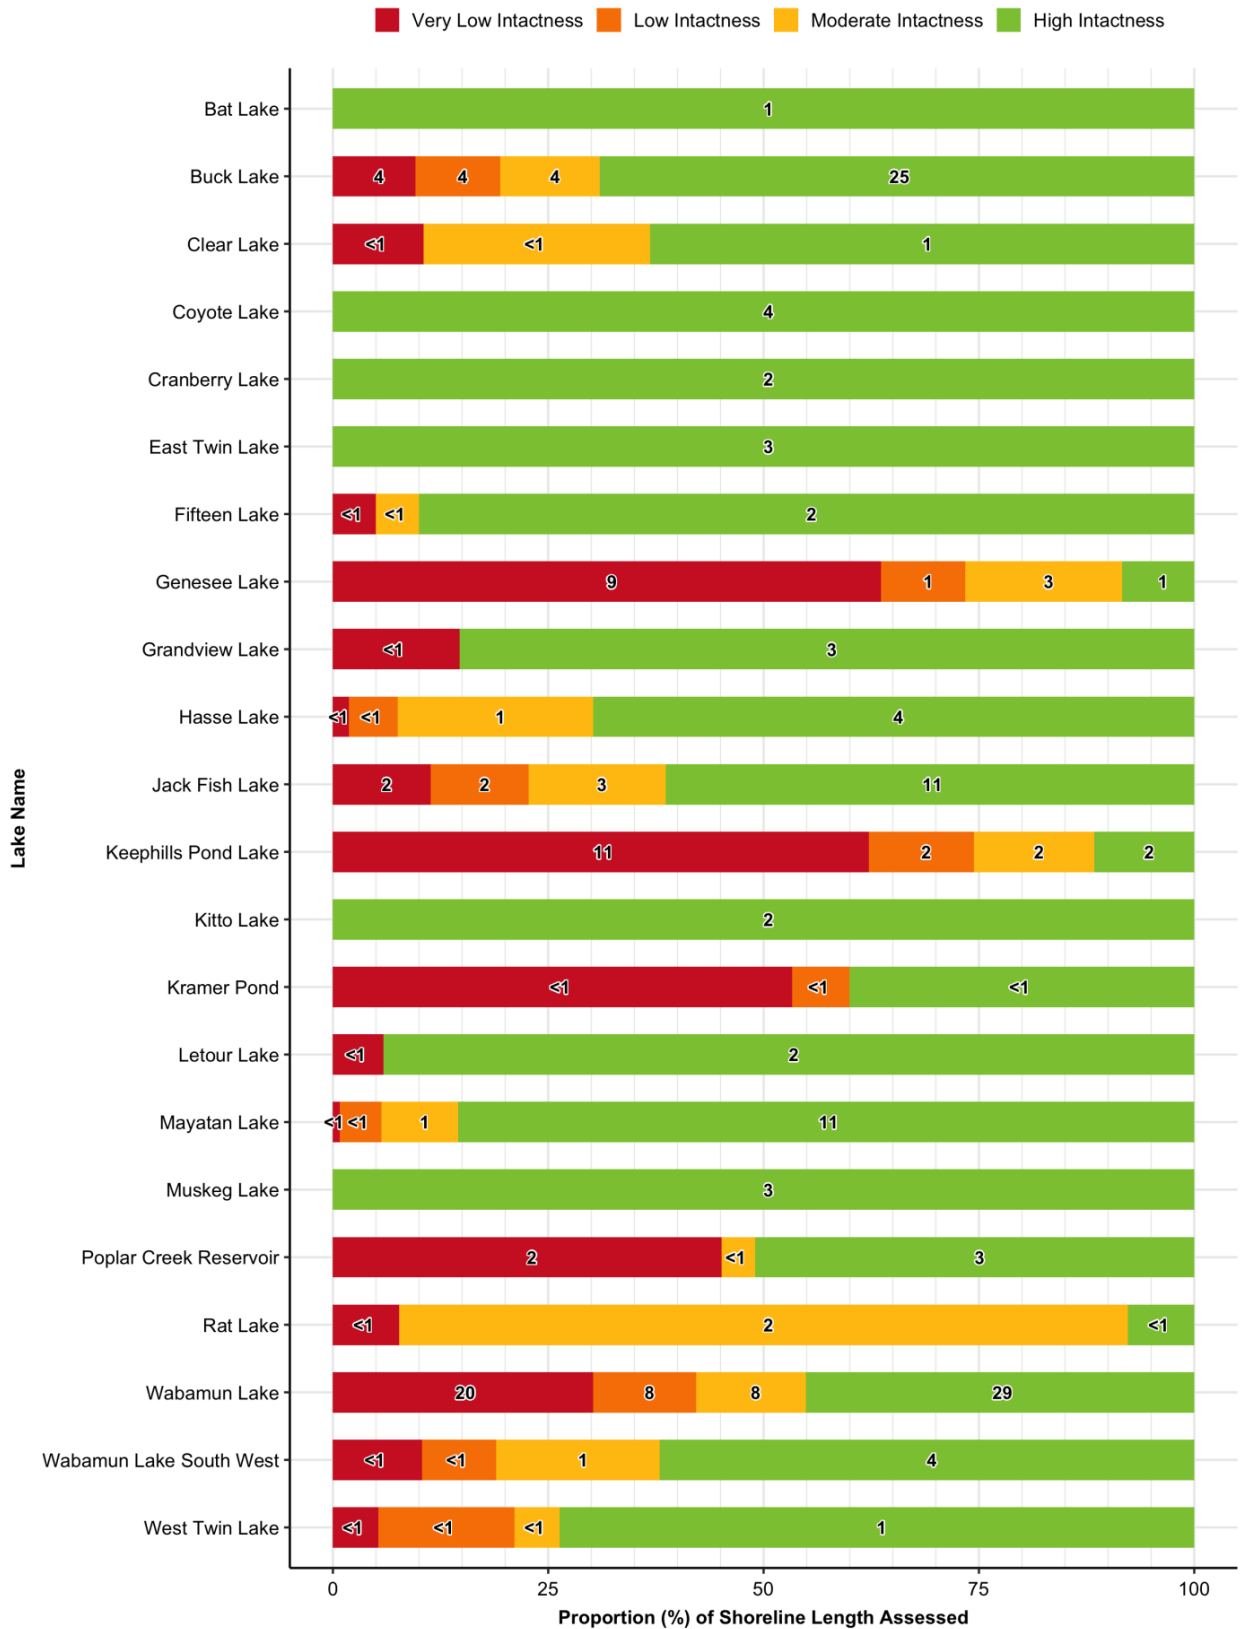
Figure 6. Comparison table of intactness in proportion to the shoreline length assessed for waterbodies in the Modeste subwatershed.

In 2021, as part of a larger assessment of the entire Modeste watershed, the shoreline of Wabamun Lake was again assessed for riparian health, this time using the satellite data method. A report on the methods used can be found in “Modeste Watershed Riparian Area Assessment” (2018) (<https://www.nswa.ab.ca/resource/modeste-riparian-assessment/>), though the results for Wabamun Lake were added after the report was finalized. The results can be found in a subsequent expansion report “Riparian Area Assessment of the North Saskatchewan & Battle River Watersheds” (2021) (<https://www.nswa.ab.ca/riparian-health-action-plan/phase-1-of-the-riparian-health-action-plan/>). Besides the methods for collecting riparian data being different, the analysis was also slightly different, in that the overall length of shoreline assessed was slightly larger (70km as opposed to 67km) but broken down into fewer segments (299 as opposed to 355) and categorized into four intactness categories: High, Moderate, Low, and Very Low. Intactness, in this case, meaning the extent to which habitat has been altered or impaired by human activity, with areas where there is no human development being classified as high intactness. The results of this riparian assessment showed that 46.5% of Wabamun Lake’s riparian area was highly intact, 13.2% was moderately intact, 11.6% had low intactness, and 28.7% were considered very low intactness (Table 1) (Figures 5 and 6). In addition to an assessment of riparian intactness, this study also included the assessment of watershed pressures (stress factors like slope, amount of development, etc.) (Figures 7 and 8) and an analysis of where

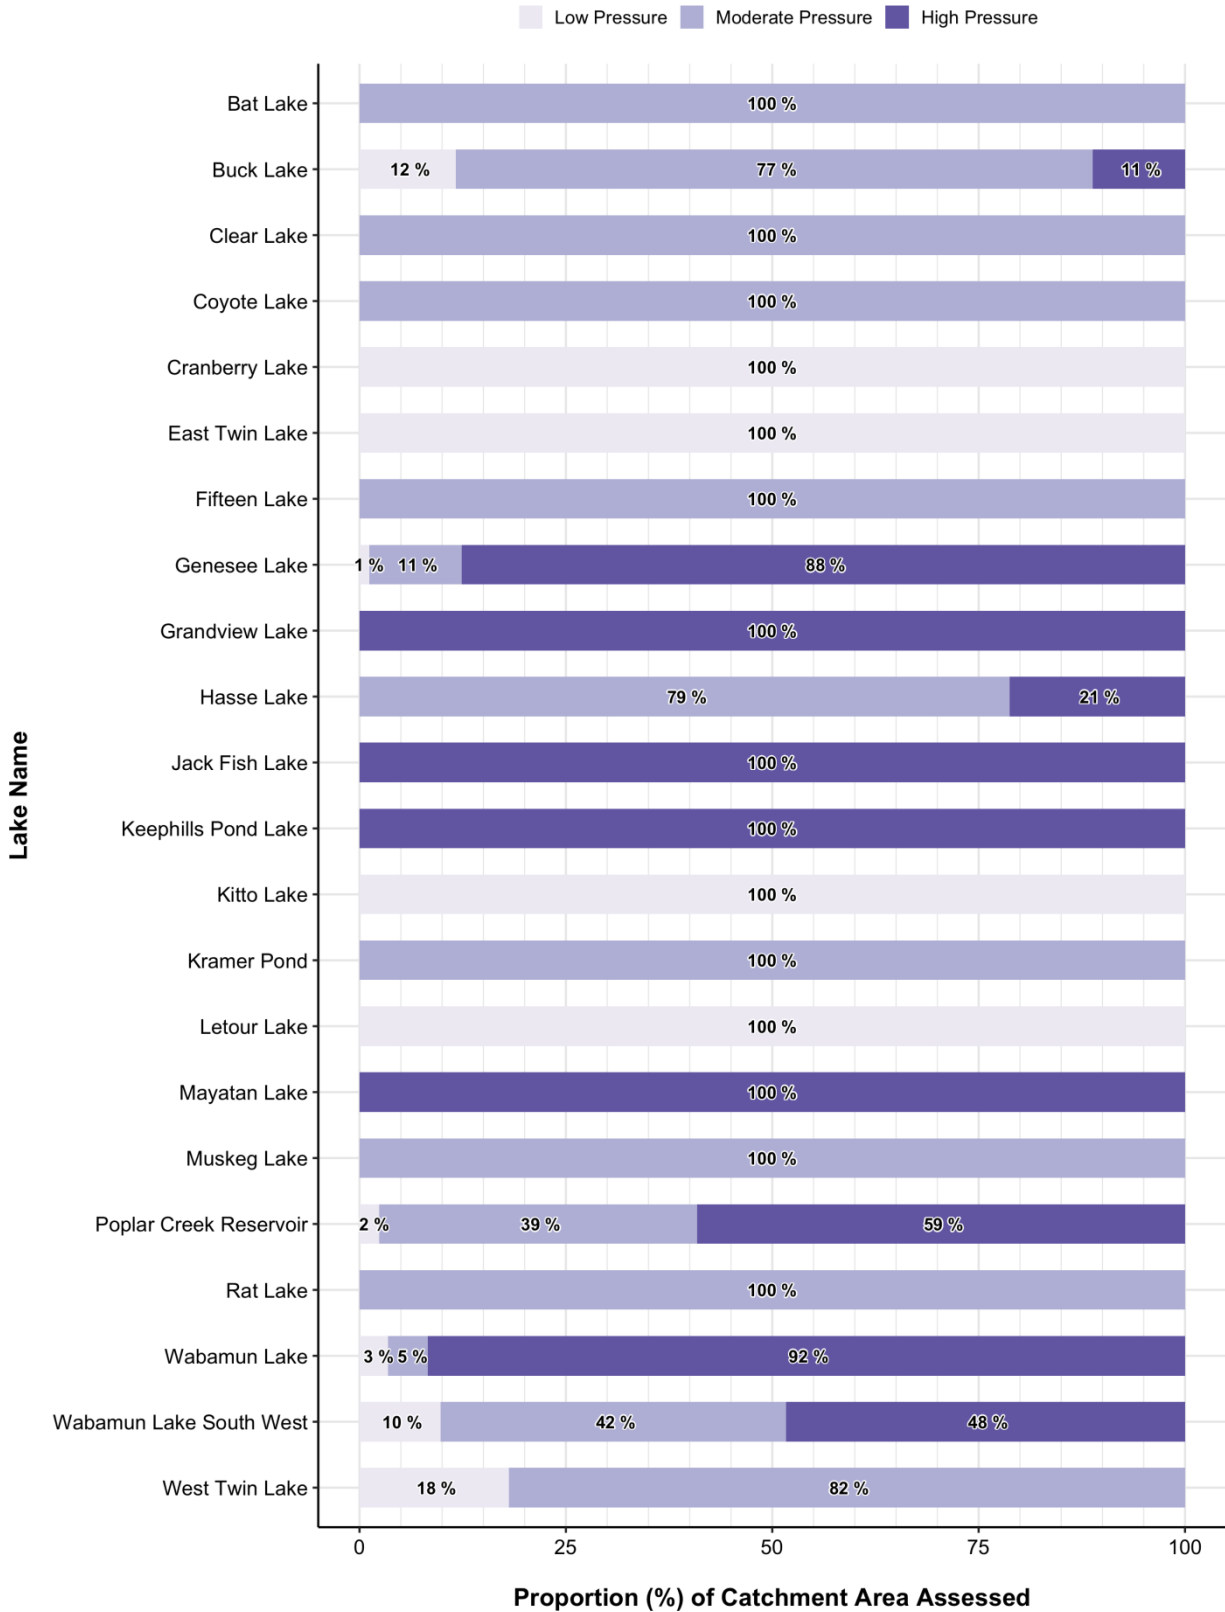
Figure 8. Pressure on riparian system function within the Modeste subwatershed as a proportion of the catchment area assessed.

While residential development around Wabamun Lake is a major cause of impairment to riparian health, activities taking place in Wabamun’s surrounding watershed are placing additional pressure on riparian health. The pressure assessment considers both natural (e.g., slope, soil type, wetland loss, forest loss) and human-caused (e.g., density of roads, paved surfaces, intensity of land use such as mining, agriculture) factors. The assessment revealed that 92% of the Wabamun watershed or “catchment area” is under high pressure (Figures 7 and 8). So, what does this mean? It means that the areas that are the highest priority for restoration action are those areas where there is both high catchment pressure draining into areas of low and very low riparian intactness.

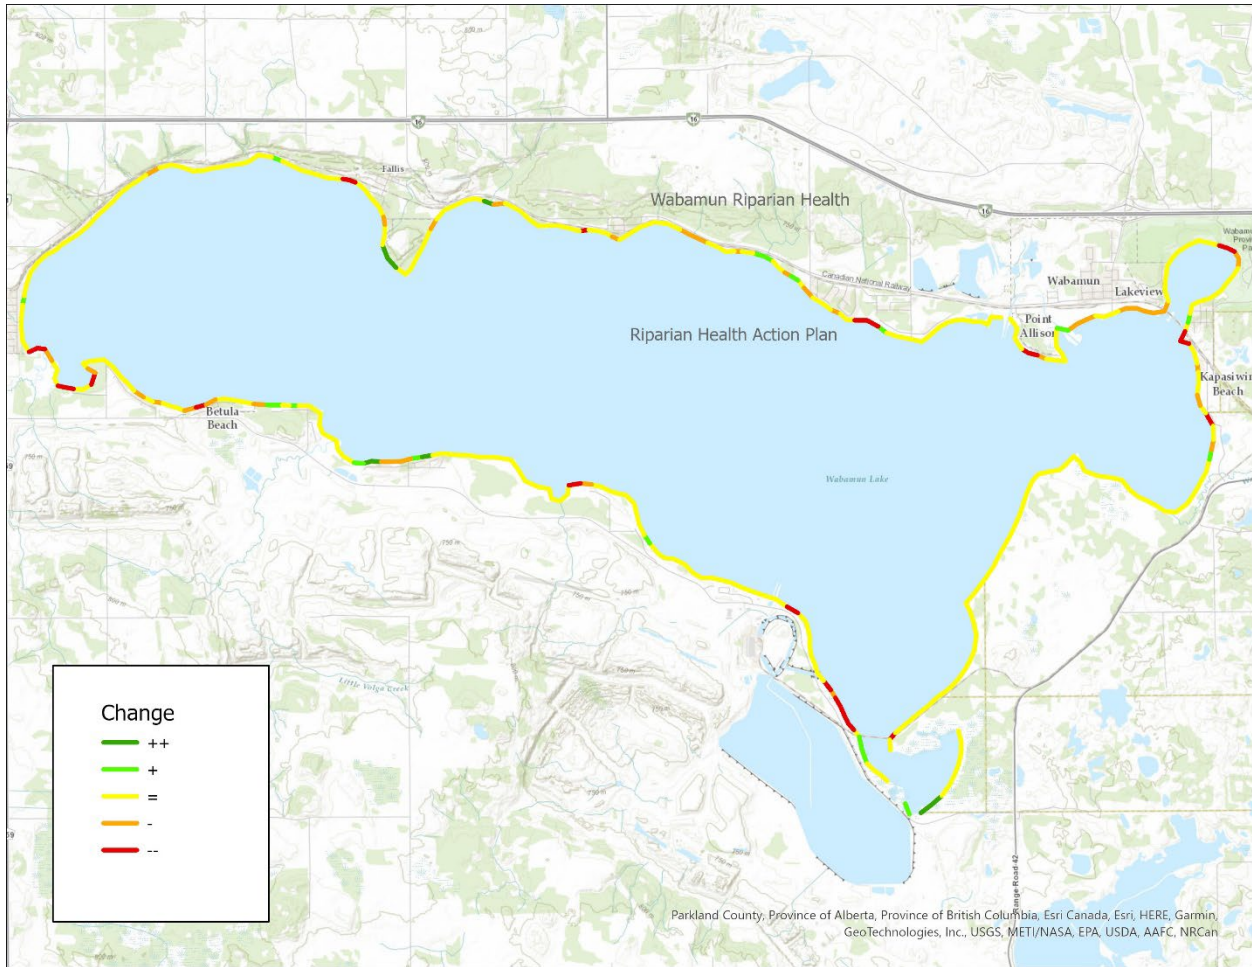
Figure 12. Map of Wabamun Lake showing where riparian condition assessment results changed from 2015 to 2021. Dark green represents a change from Low health to High Intactness, light green is low health to moderate intactness, yellow is unchanged, orange is going from High health to Moderate Intactness and red is from either high health to low or very low or moderate health to very low intactness.

By and large, the results from the two assessment methods are agreeable. Where the two results disagree, this could be attributed to either a) a change in landscape over the 5-year period between the two assessments, or b) a difference between the methods for assessing riparian condition. Reasons for the differences in the assessment methods could be due to the difference in segment length and width, or due to a difference in the assessment criteria despite the effort to make them “comparable”. Overall, the difference between the two methods does not significantly change the results, as some areas show an improvement and other areas show a decline, but mostly, they are the same (Figure 12).
